**INTERSTATE 29 NORTHBOUND  
BRIDGE over the  
PERRY CREEK CONDUIT**

**SIOUX CITY, IOWA**

**FIRE DAMAGE INSPECTION  
REPORT**

**NOVEMBER 2, 2019**

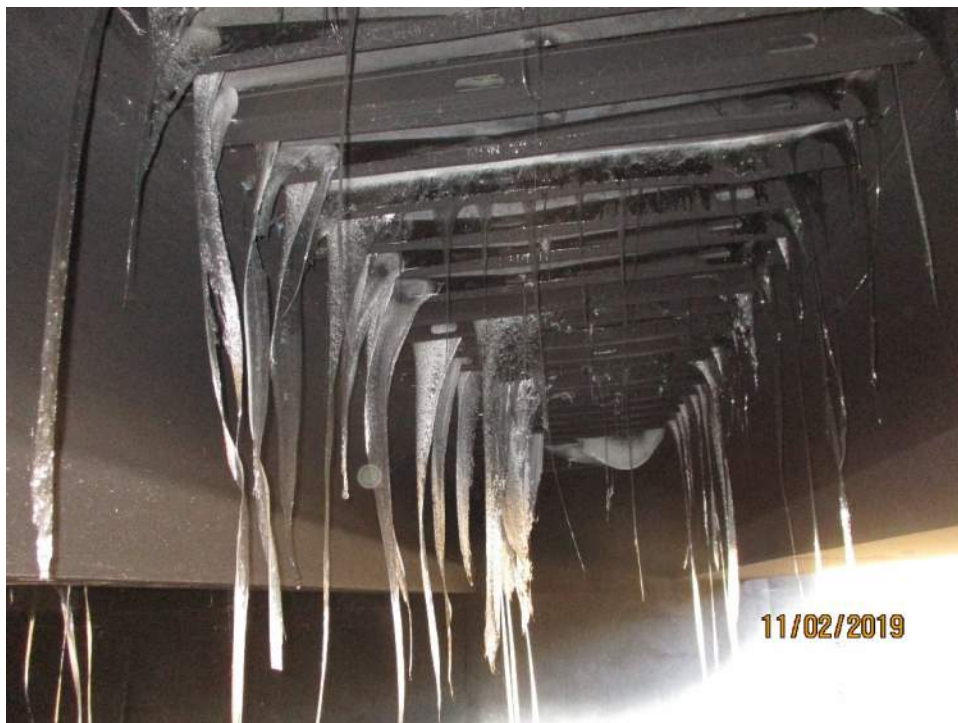
- The deck soffit between Beams “A” and “C” was soot covered but had no noticeable damage.
- Minor surface spalling of the deck soffit was observed between Beams “C” and “D” with hammer sounding finding noticeable delaminations.
- More extensive surface spalling was observed from Beam “D” to Beam “G” as well as the east half of the soffit between Beams “G” and “E”.
- Hammer sounding found no noticeable concrete delamination.
- Polycarbonate stay-in-place forms used between Beam “D” and “H” had been consumed.

*Photo 002: Aluminum supports Between Beam "G" and "H", melted polycarbonate forms.*

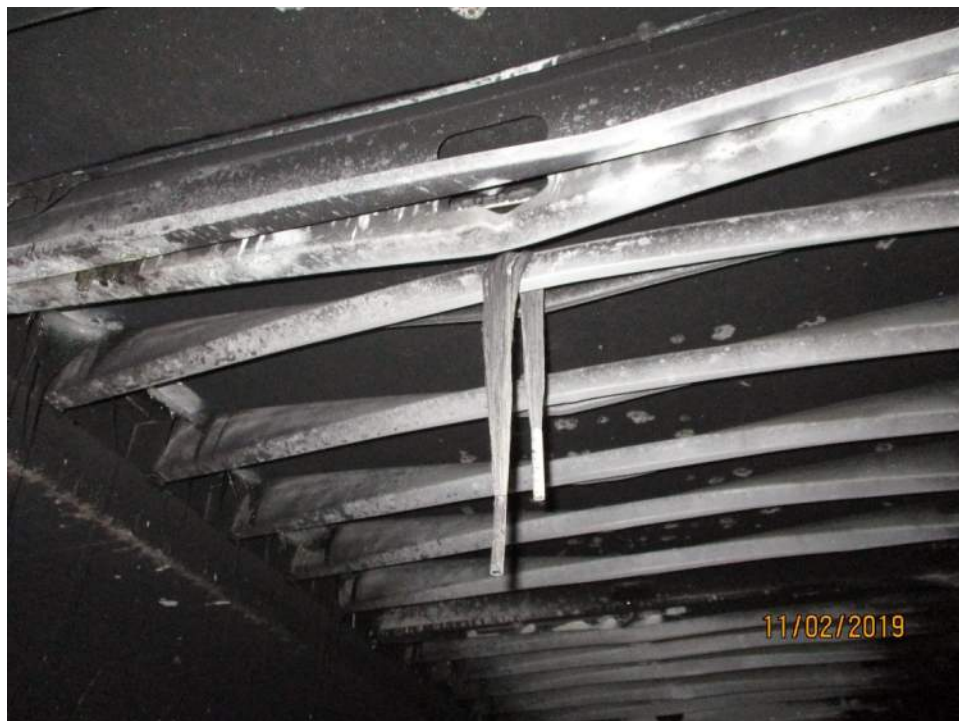
*Photo 016: Melted Formwork between Beams "G" and "F"*

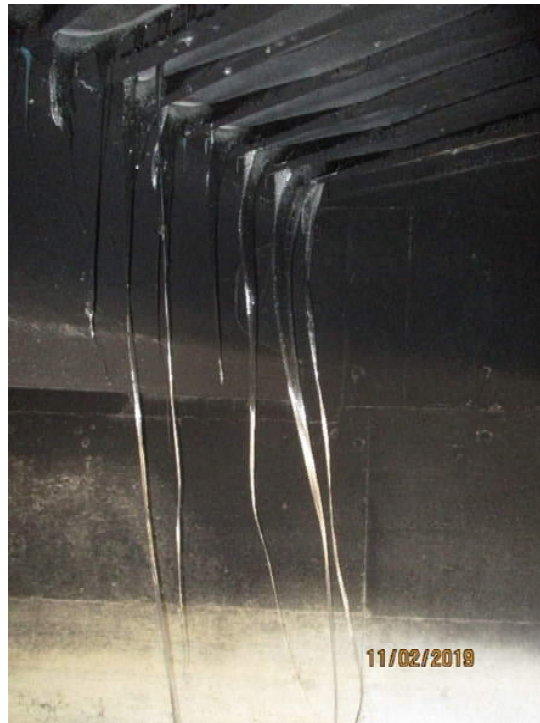
*Photo 017: Melted Formwork Between Beams "G" and "F"*

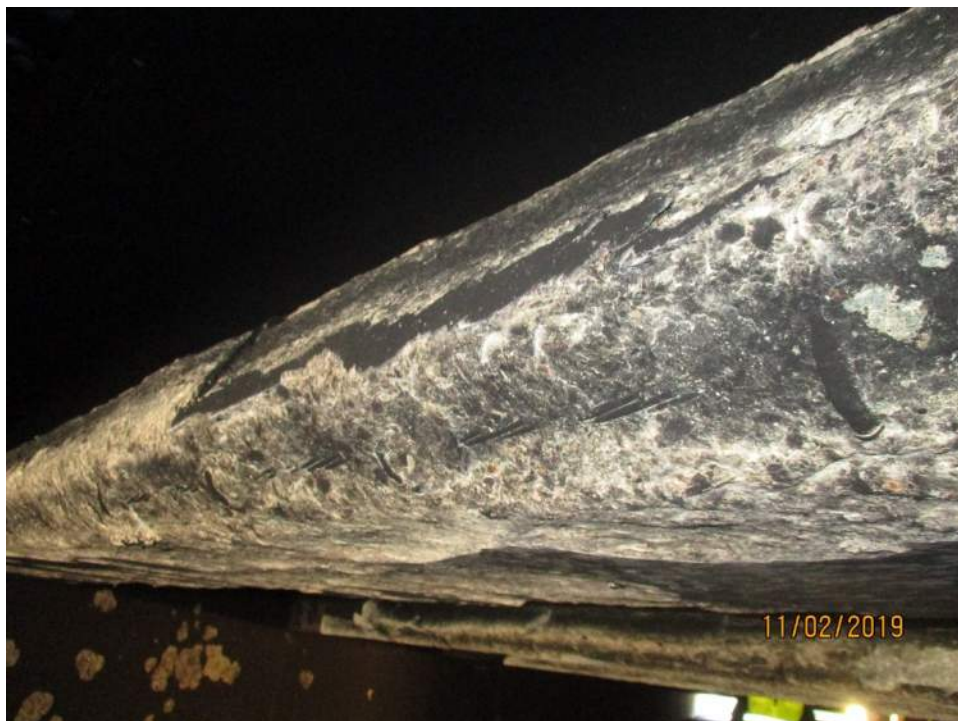
- Beams "D", "E", and "F" were observed to have extensive bottom flange spalling and delaminated concrete for the length of the beam.
  - Both exterior strands in the bottom layer of strands were exposed and soot stained the majority of the length of all three beams.

*Photo 024: Beam "F" – Exposed Strand and Stirrups, North Face*

1. Maintain traffic only between Beams “A” and “C” unless load testing is completed to verify the capacity of Beam “D”.
2. Replace damaged beams.

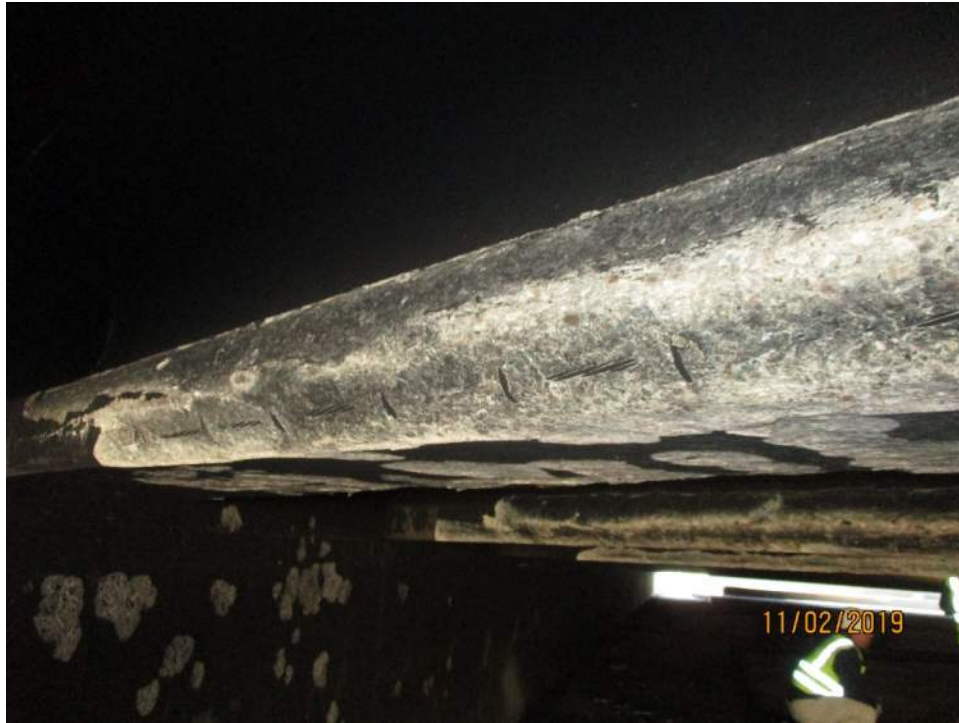
*Photo 025: Beam "F" – Exposed Strand and Stirrups, North Face*

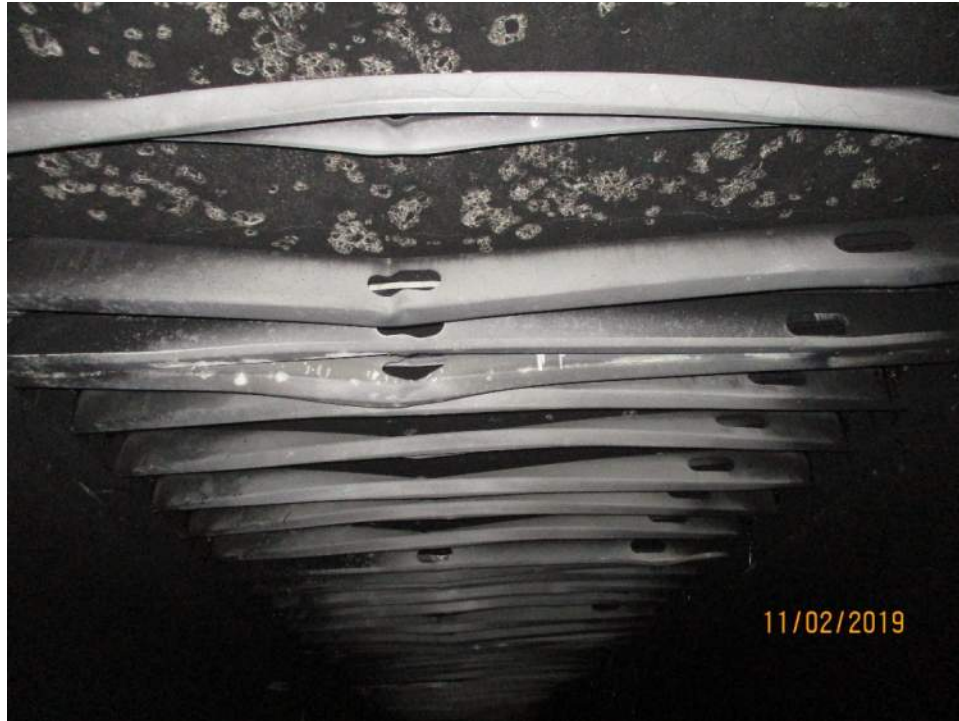
*Photo 035: Deformed Formwork supports between Beams "F" and "E"*

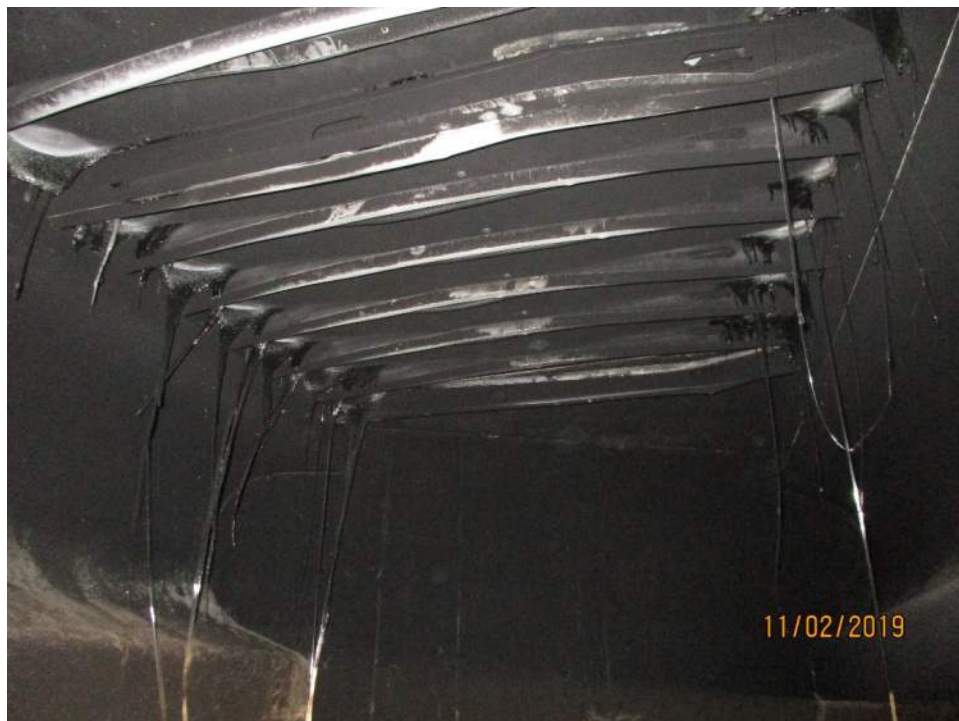
*Photo 036: Deformed Formwork supports between Beams "F" and "E"*

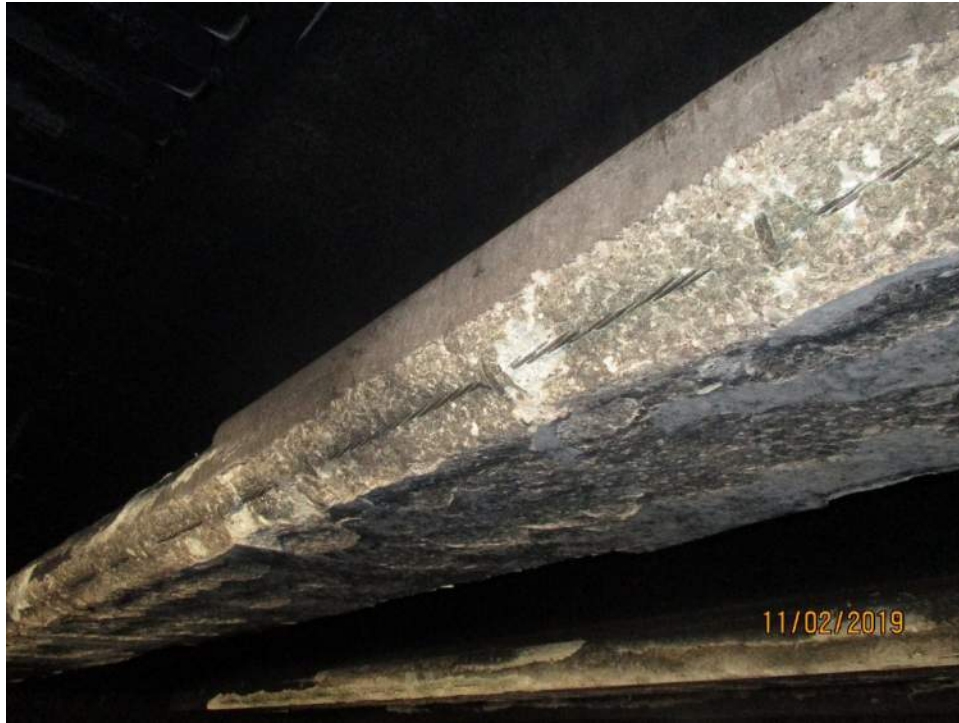
*Photo 043: Beam "E" – Exposed Strand and Stirrups, North Face*

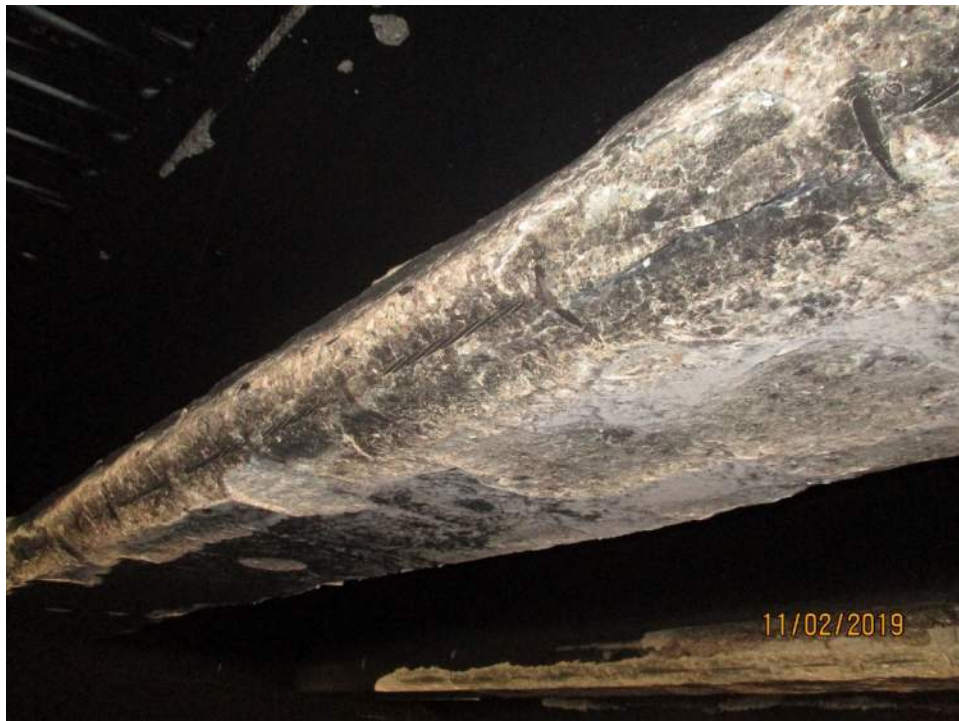
*Photo 044: Beam "E" – Exposed Strand and Stirrups, North Face*

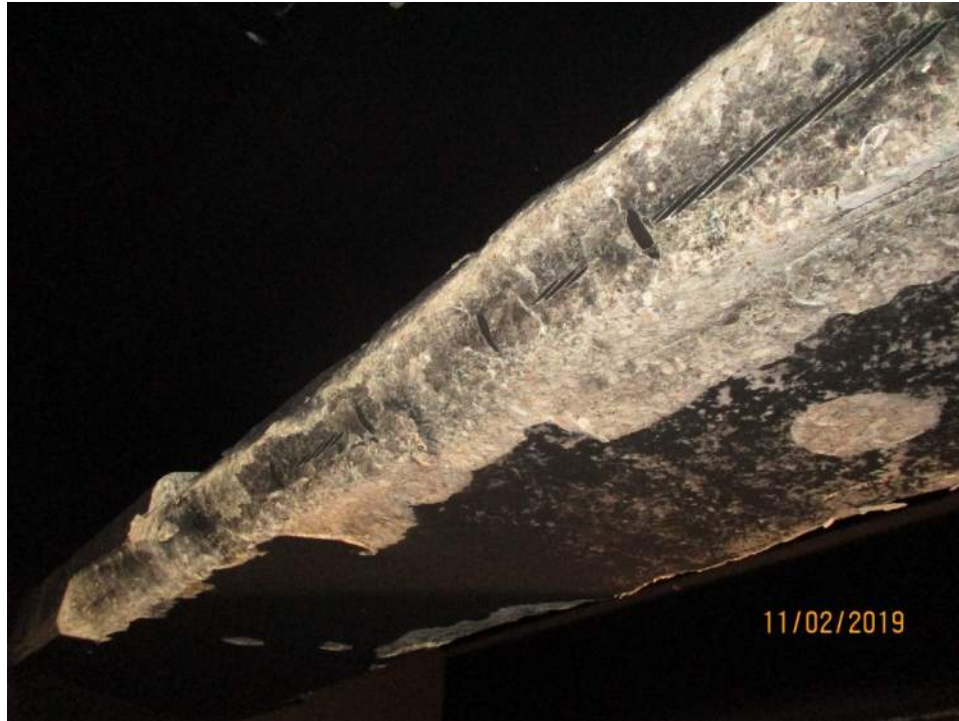
*Photo 045: Beam "E" – Exposed Strand and Stirrups, North Face*

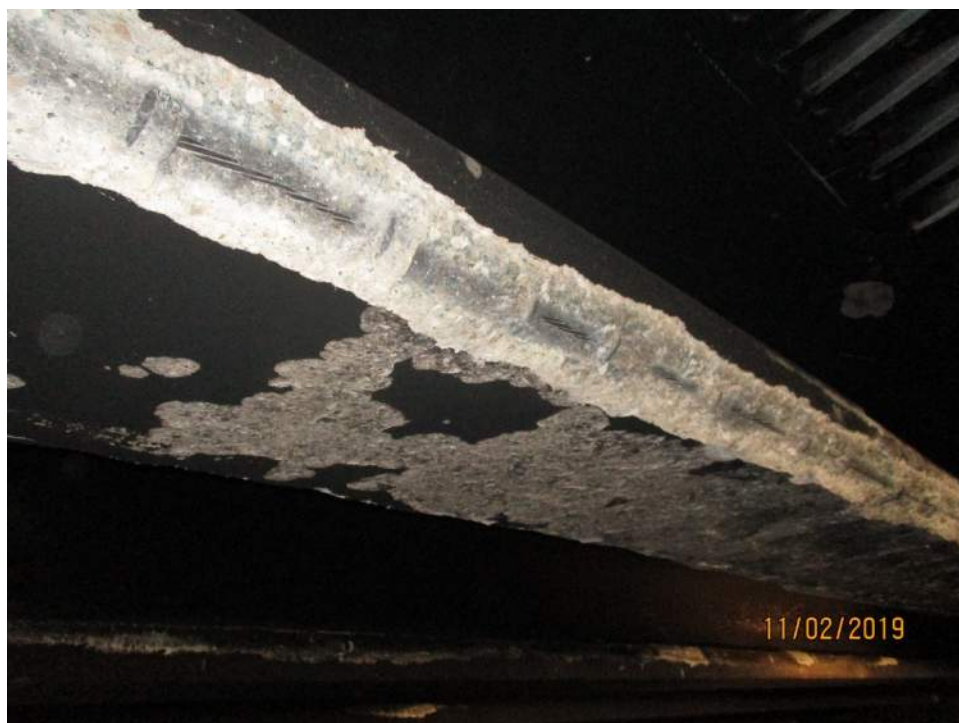
*Photo 056: Beam “D” – Exposed Strand and Stirrups, North Face*

- Beam "D" should be load tested to see if a second temporary NB lane can be added.
- Beams "D" through "F" took the worst of the damage and would probably behave similarly. At a minimum, load testing should be done on top of Beam "D". If other damaged beam lines are considered for supporting live load, additional beam live load testing could potentially be considered.

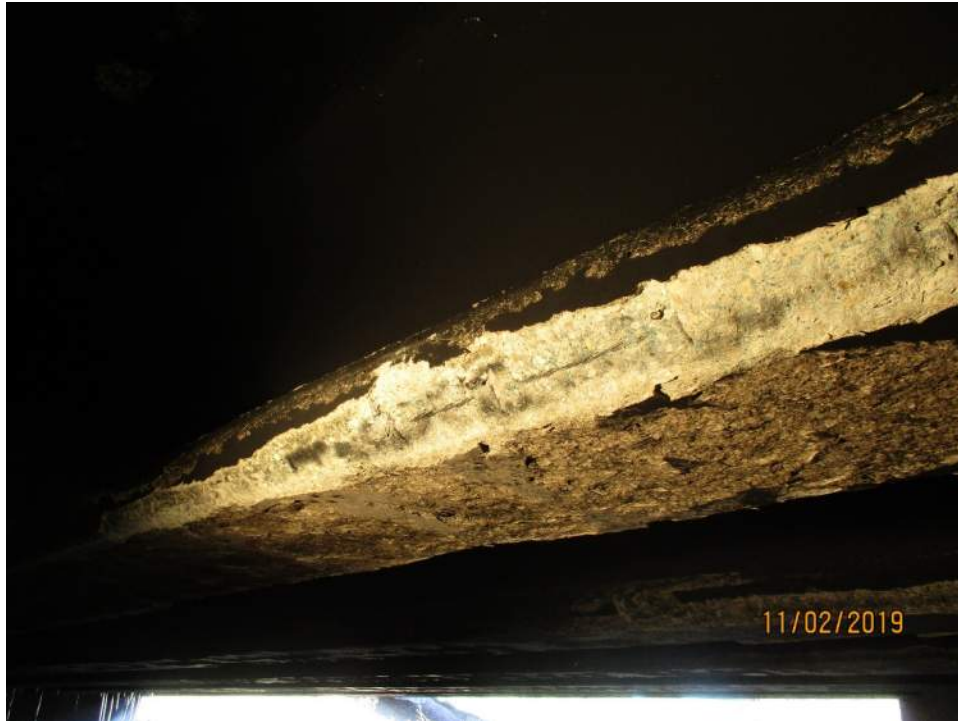
*Photo 057: Beam “D” – Exposed Strand and Stirrup, South Face*

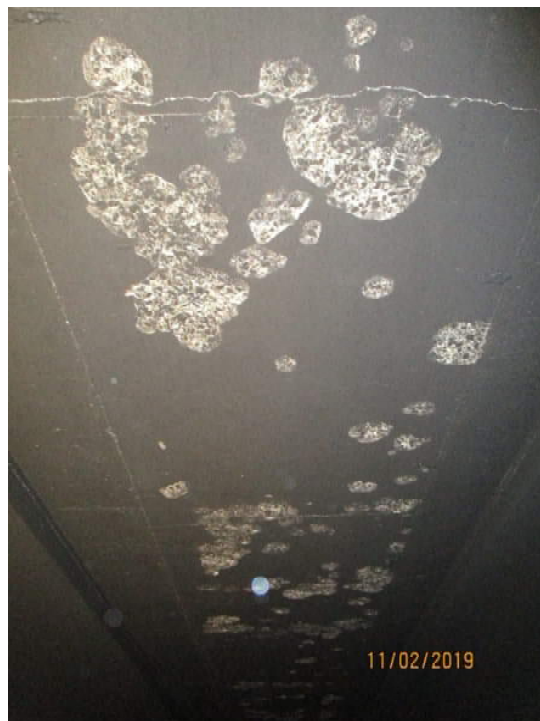
*Photo 058: Deck Spalling between Beams “D” and “C”*

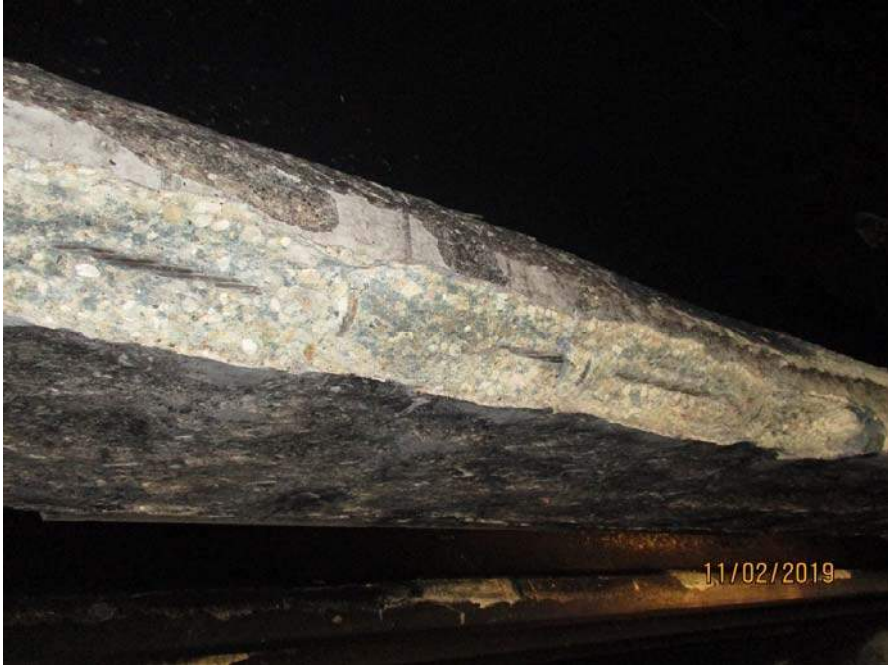
GIRDER "D" – BOTTOM FLANGE  
SPALLING AND EXPOSED STRAND,  
NORTH FACE

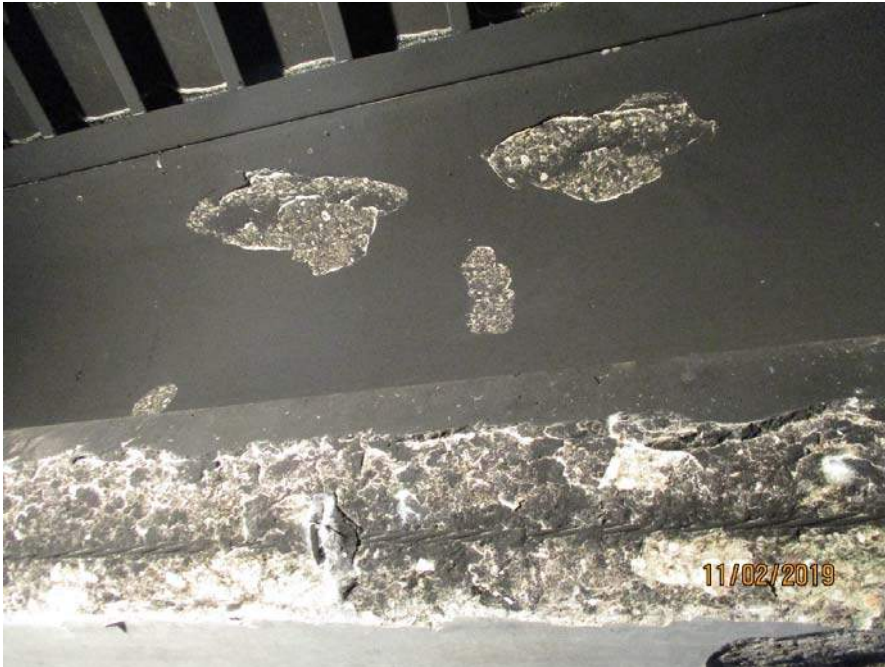
- Web spalling was observed on the north face of Beam "D" and the south face of Beam "E".
  - Sounding indicated delaminated concrete on the top flange of the north face of Beam "D" as well as the top flange on both faces of Beam "E".

GIRDER "E" – BOTTOM FLANGE  
SPALLING, EXPOSED STRAND, AND WEB  
SPALLING, SOUTH FACE

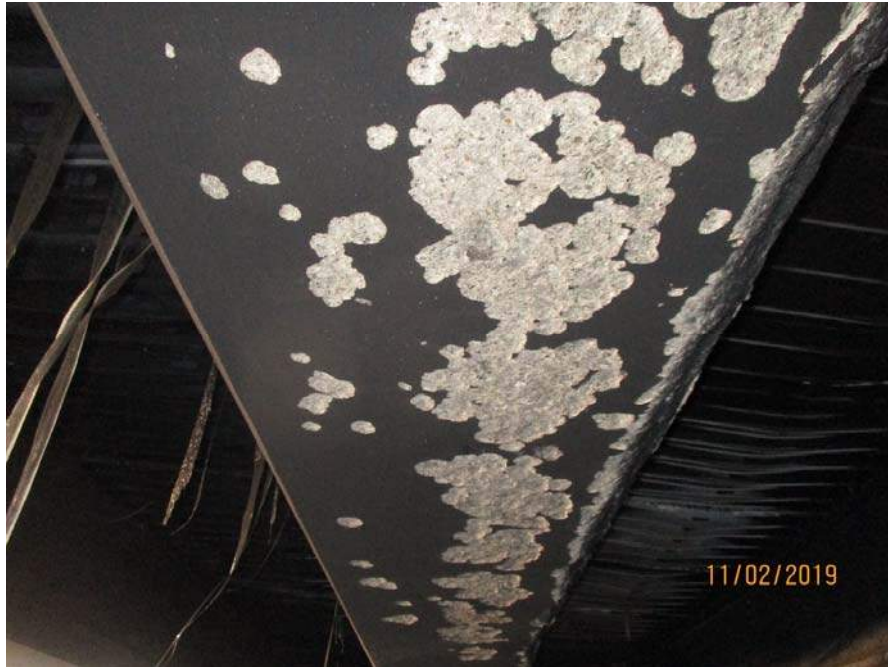
- Beam “G” was observed to have bottom flange spalling and delaminated concrete.
- The bottom exterior strand was exposed and soot stained at the south face of the beam.
- The top edge of the bottom flange had surface spalling on the north face of the beam.
- Remaining camber was visually approximated to be between ½” to 1”.

GIRDER "G" – BOTTOM OF BOTTOM  
FLANGE, MINOR SPALLING

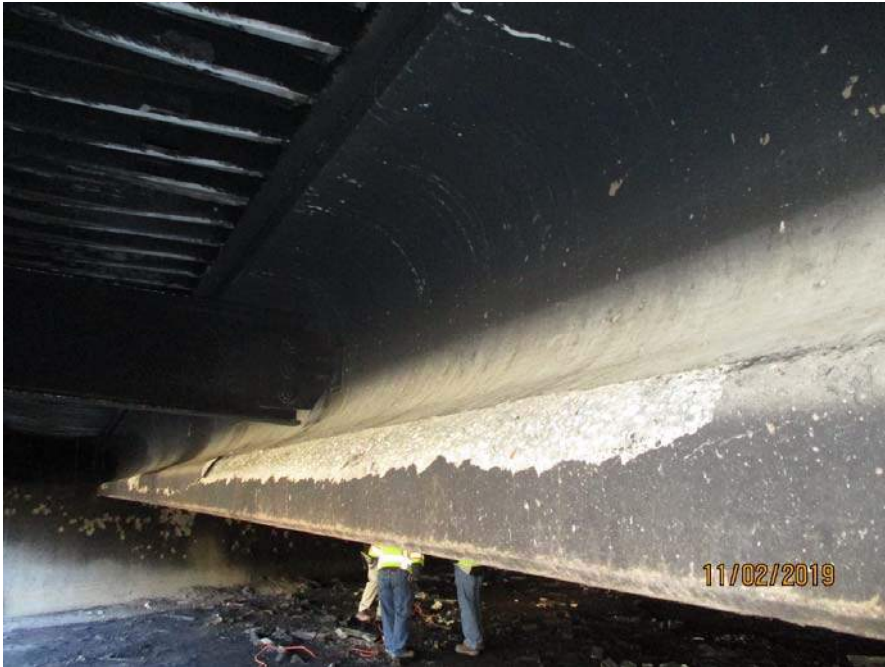
GIRDER "G" –BOTTOM FLANGE MINOR  
SPALLING, NORTH FACE
